Arctic Oil Leak 2020: Not a recent Phenomenon – Reveals Satellite Imagery

Satellite Imagery Analysis

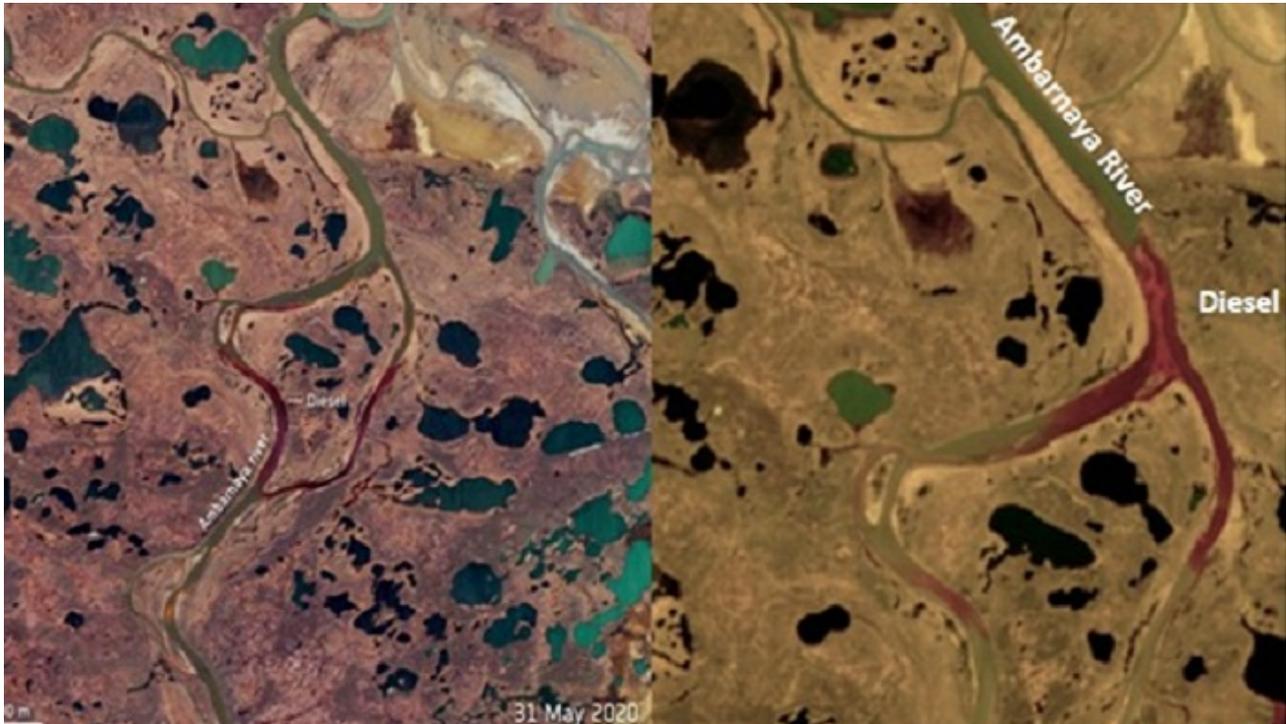
the Sentinel-2 data shows river Ambarnaya and its banks becoming 'red' Figures 1Source: ESA (Sentinel-2 Image) | ESA Team, 6th June 2020. Figure 2 (Source: ESA Image | Author) shows the flow of the Oil on 1st June 2020 moving in the northward direction. The diesel in this case was dyed red, to classify and segregate its use for particular tasks. Hence when this diesel spilled it turned river red.

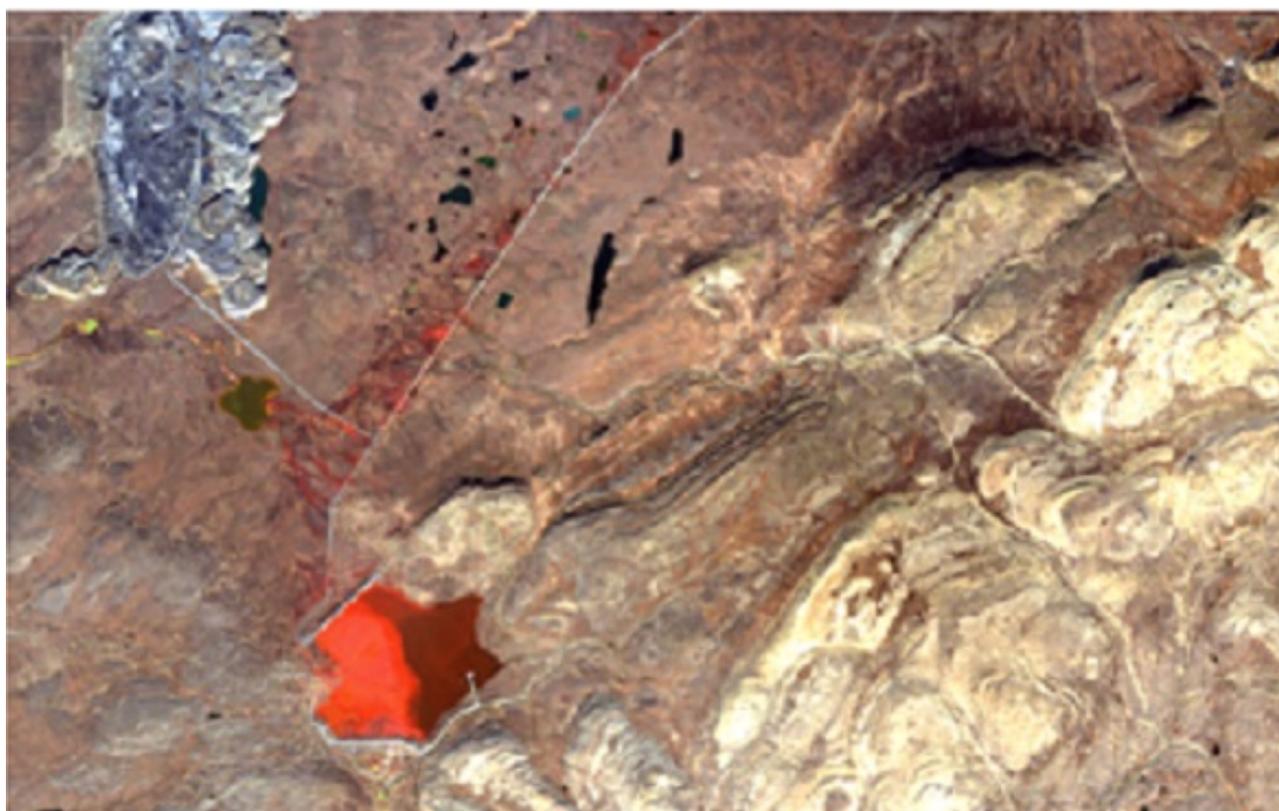
Figure 3: River flow and a small pond – Daldykan – turns Red (2016)

The all-too-well known environmental dangers from this contaminant material spill is not a recent phenomenon. There were reports of chemical leaking into the river and neighboring small water bodies in 2016, Figure 3. In 2016, the river Daldykan turned red due to leaking materials that contaminated the river water. The National Geographic came out with an article (among others) in 2016 and raised important questions towards the reddening of the rivers and the possibility of the chemicals being leaked into the adjoining areas and these rivers. Though at that time it was also speculated that heavy iron content from the ground gave rise to red color in the river. The published reports at the time put pressure on Norilsk Nickel and it subsequently admitted to leakage from a dike at the Nadheзда plant that caused overflowing of contaminants into the river, making it red, Figure 3.

During the 2016 chemical leakage, the source of the river turning red was not immediately accounted for, unlike the stated fuel spill in May this year, where the attribution to red-colored diesel has been immediately made. The additional reason for the massive amount of leakage this year has also been attributed to the melting of Permafrost. Though this may be true because a whole storage facility is said to have collapsed, the 'red' coloring of rivers in the region can be seen as back as 2016 (Figure 3) and 2010 (Figure 5), it does not address the issue completely. This has also been reflected in the strong stance taken by Russian authorities in holding the responsible actors accountable and liable for legal action if found guilty, even if permafrost was found to be the reason for the collapse of the structure. It is possible that the spread of diesel and other chemicals at the site may have occurred, (seen through the satellite images), due to unintended leakage for the lack of required maintenance and upkeep.
